Invoice #:	3157
Work Order:	WO-00001780
Service Date:	01/09/2015
Technician(s):	William Haddow Ian Frick
Equipment #:	6628121

Engine Diagnostic

Equipment #	VIN	Equipment Year/Make/Model	Application	Muffler Configuration
6628121	1M1AK05Y67N012843	2006 Mack CXN613	Shipping (local: USPS, U-haul, UPS, etc)

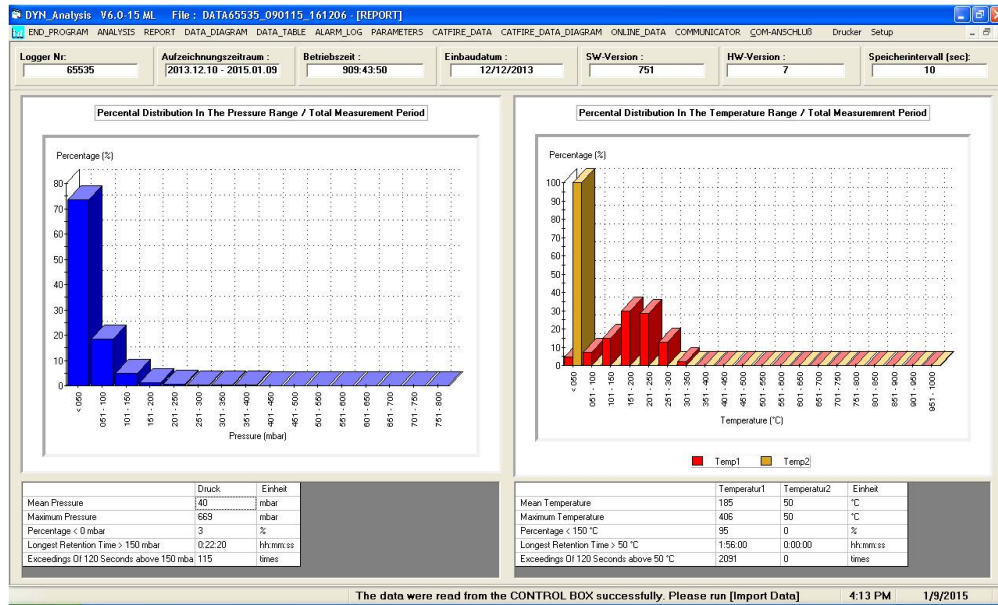
Data Plot of Temp and Pressure (Lifetime data - since Dec 2013)

Exhaust Temperatures rarely breaking 300 Deg C

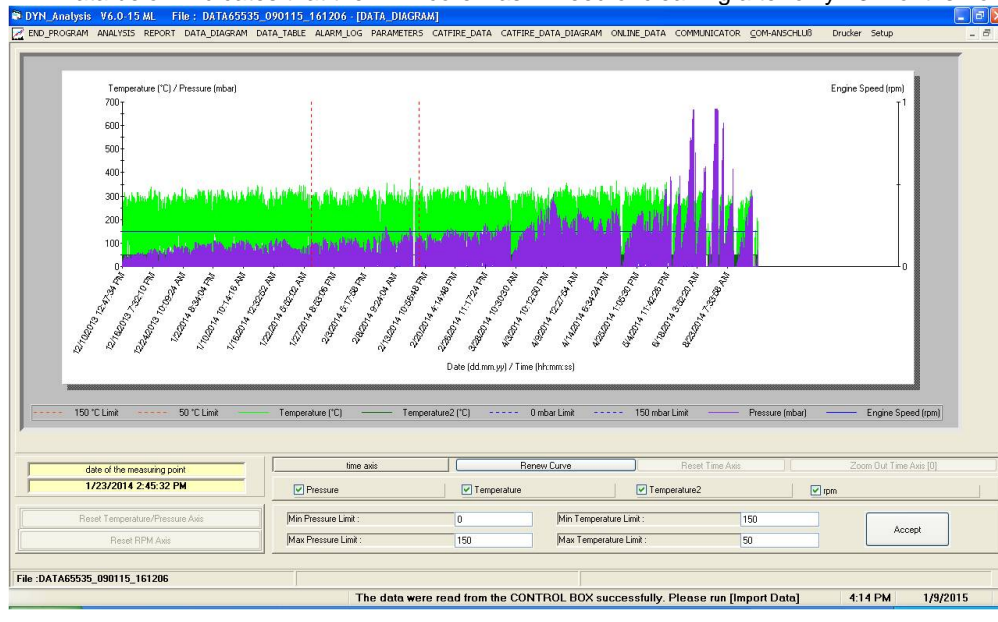
ALL Data below indicates that the DPF core was in need of cleaning after only ~3 months from date of install in Dec 2013

Performed Data Download of HUG System by use of CPK TERMINAL. Found the HUG DPF System functioning normally. However, the DPF core is soot loading very prematurely (most likely due to engine issue). Removed the DPF core for cleaning. Cleaned the core, and reinstalled. Found some exhaust clamps leaking, replaced as needed.

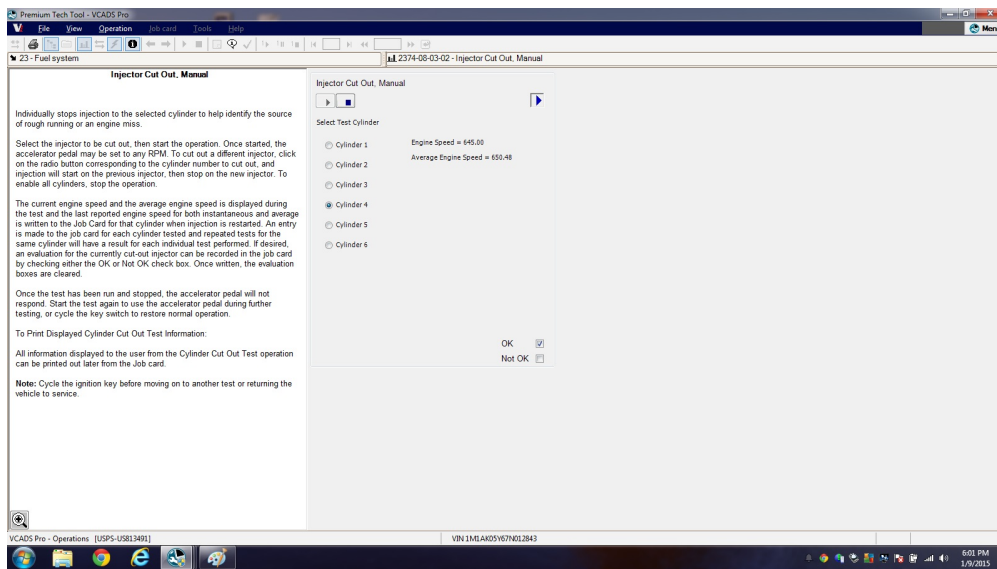
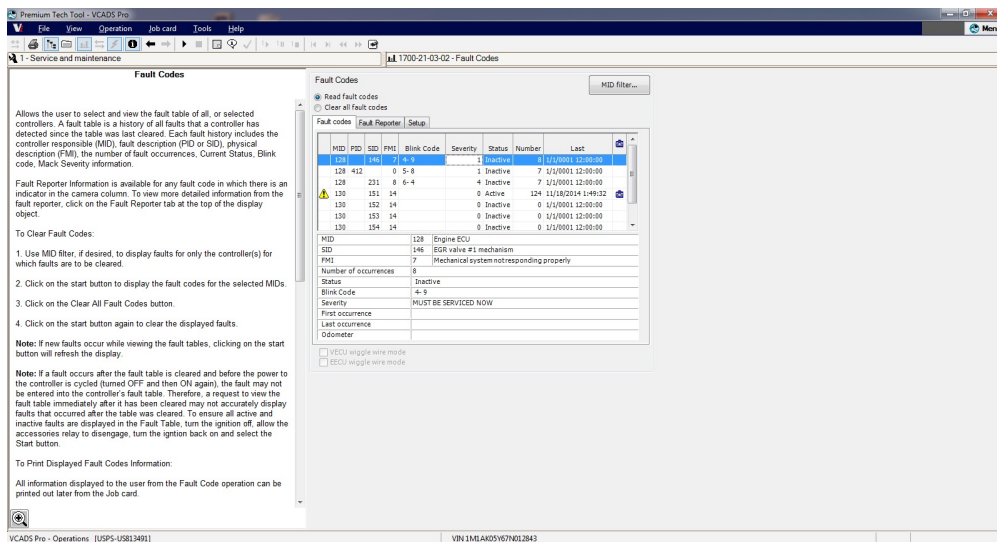
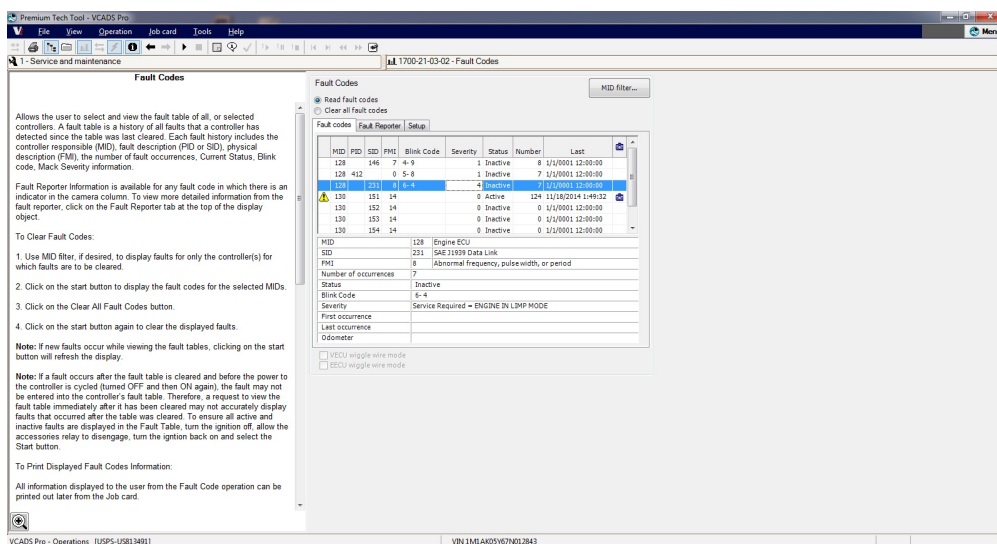
Performed various engine diagnostics, found misfires on #3 and #4

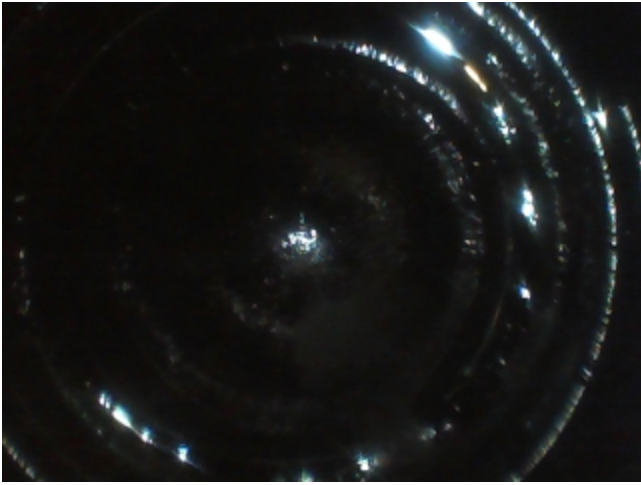
When removed NOZZLES, discovered one cylinder heavily carboned over, and had to be bored out

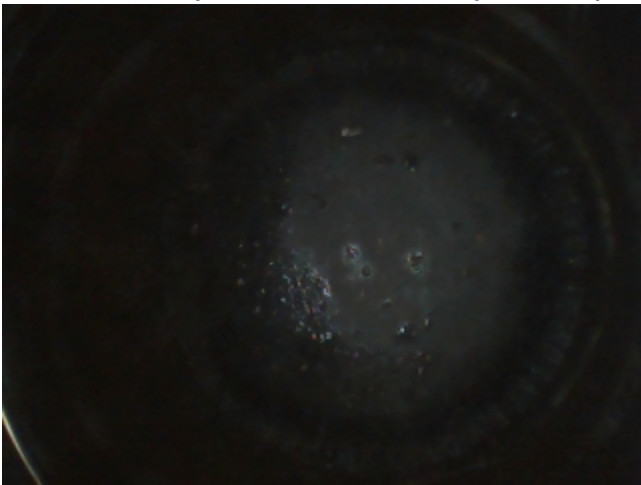
Discovered Cylinder #6 had heavy ash deposits and signs of predetonation

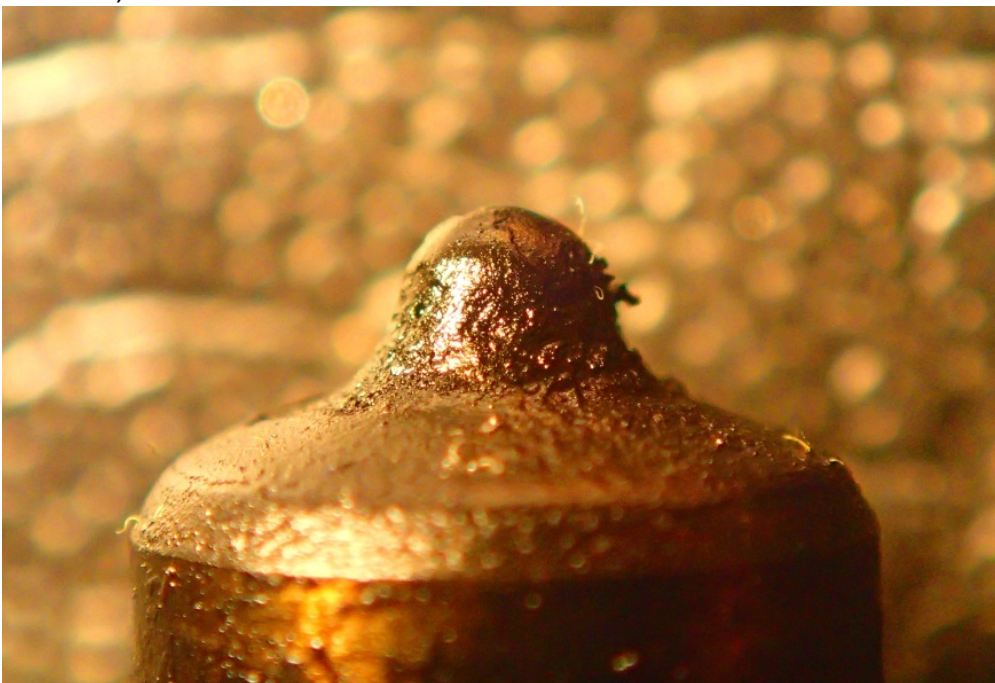
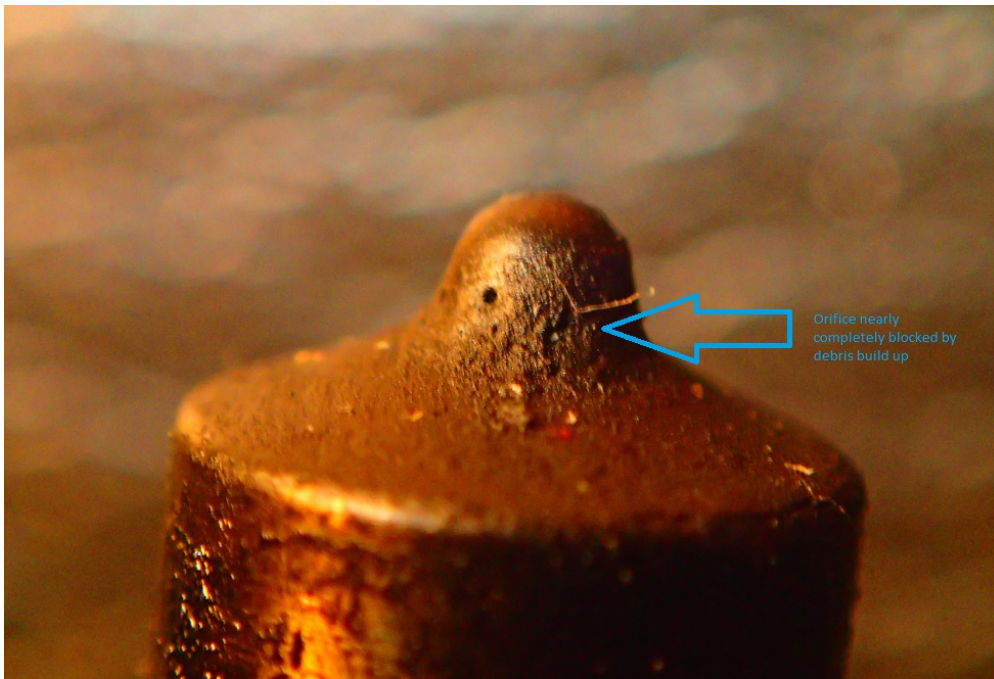
Removed Fuel Nozzles and discovered heavy blockage on #3 and #4 (install ALL NEW Fuel Nozzles)

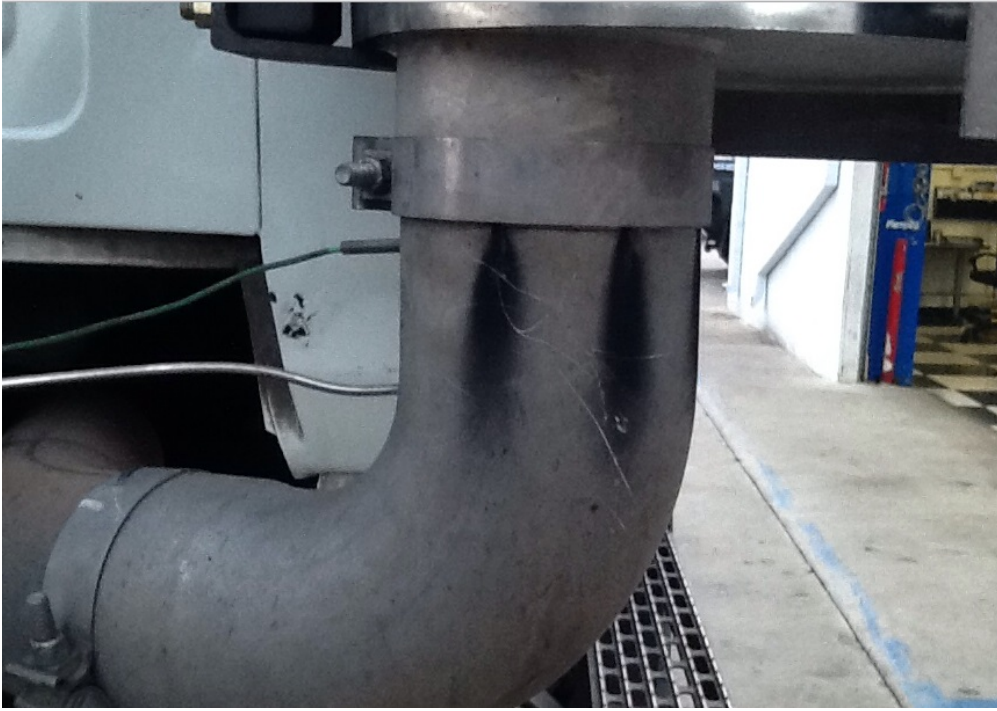
Found heavy exhaust leaks at Accuseal Clamps (removed)

Installed SEAL CLAMPS in place of all leaking AccuSeal (TM) Clamps (and cleaned all soot off truck)

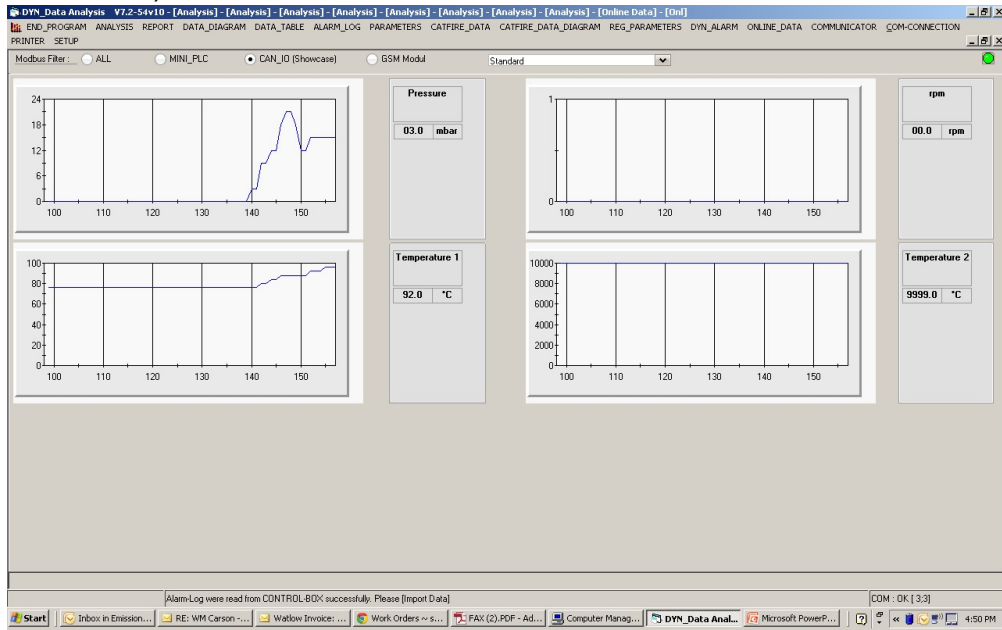
Post DPF Cleaning, Exhaust Pressure (original was nearly 60mBAR at fast idle, now only ~20mBAR)
